AA-964 1913

"B" Building Public

Crownsville Hospital Center

aryland Historical Trust State Historic Sites Inventory Form

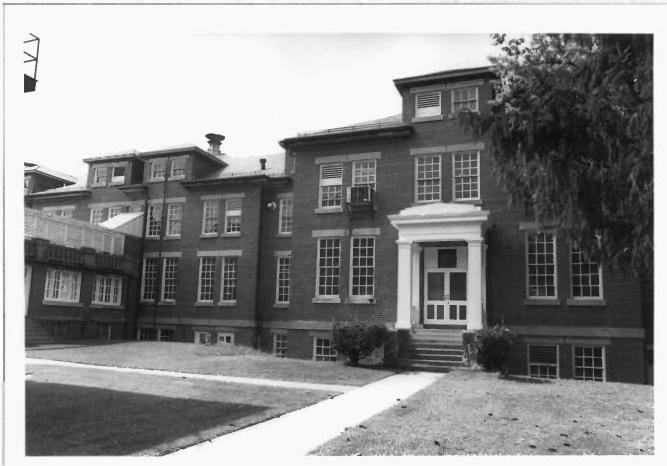
AA-964
"B" Building
Crownsville Hospital Center
Crownsville, Maryland
Don Jewell, 9/86
Negatives at MHT
NORTHEAST

"B" Building is located directly west of the Administration Building and is linked to it by an enclosed corridor. The building is three stories in height and is composed of three main pavlions connected by two wings of two bays wide. The two end pavilions measure six bays wide and four bays deep while the central pavilion is larger measuring nine bays wide. The elongated structure displays a slate covered, hipped roof, and faces east. "B" Building connects directly into the Hugh Young Building on the south and "C" Building on the north.

The north and south pavilions share similar architectural elements. In addition to the previously described fenestration, the end pavilions each have a central portico. Tuscan pillars and pilasters support the developed entablature. Constructed of concrete, the portico exhibits a flat roof with a recessed triangular pediment. The portico incorporates only one bay of the pavilion.

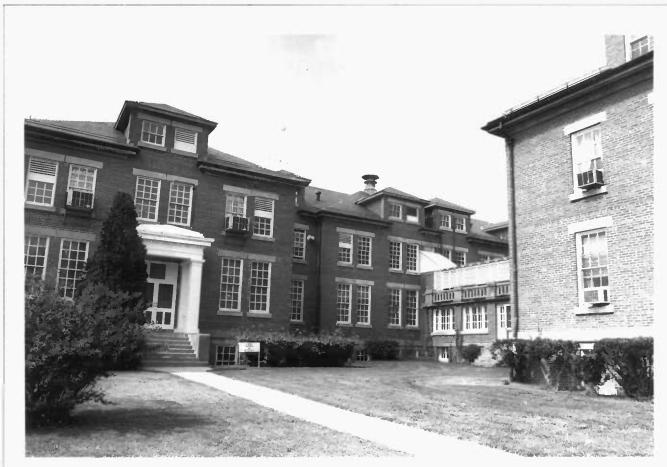
AA-964
"B" Building
Crownsville Hospital Center
Crownsville, Maryland
Don Jewell, 9/86
Negatives at MHT
Southeast

The connecting wings and the central pavilion employ the standard elements such as the concrete water table, cornice and wall dormers. The main distinction of the central pavilion on the east wall is the connection to the enclosed brick corridor which links "B" Building with the Administration Building. For a complete description of the corridor, please refer to the inventory form for the Administration Building.

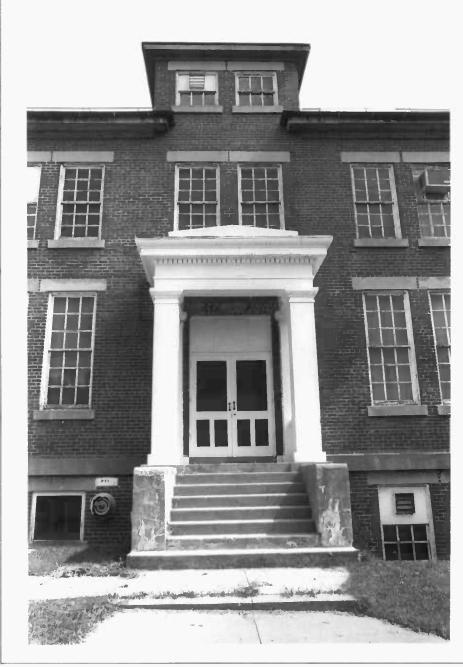
AA-964
"B" Building
Crownsville Hospital Center
Crownsville, Maryland
Don Jewell, 9/86
Negatives at MHT
WEST, PORTICO DETAIL

The west facade of "B" Building is a continuous twenty-five hays while still distinguishing the north, south and central pavilions. The most distinctive feature of the west face is the number of concrete porticos. They appear on the pavilions as well as the connecting wings. While they vary in width, all the porticos are one story in height. The pillars are simply detailed while supporting a flat roof. A dentil course enhances the entablature. A concrete balustrade with rounded arches encloses the portico. One portico has been altered to a steel and concrete loading dock.

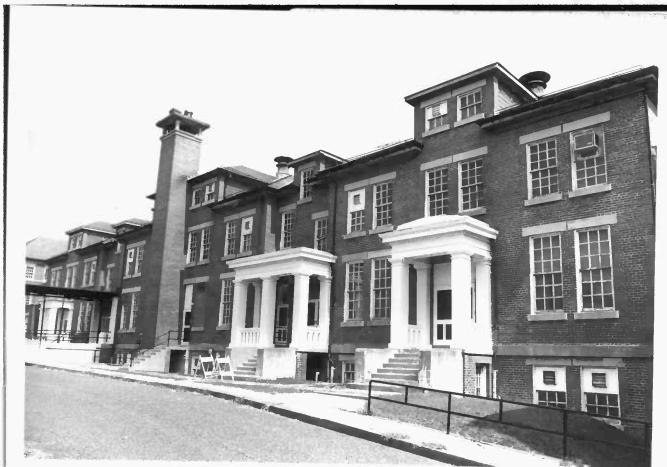
AA-964
"B" Building
Crownsville Hospital Center
Crownsville, Maryland
Don Jewell, 9/86
Negatives at MHT
West

The west face of the central pavilion displays an exterior wall chimney. Constructed of common bond brick, the square chimney has a concrete capstone and is flanked by wall dormers.
